Introduction

Milone & MacBroom, Inc. (MMI) was retained by the Town of Simsbury to develop an Open Space Improvement Plan for the 375 acre Ethel Walker parcel located in Simsbury, CT. The goal of the Open Space Improvement Plan was to identify existing passive recreational opportunities on the parcel, provide enhancement strategies for improving the sites existing and/or future recreational capabilities, provide a long term sustainable recreational management plan for the parcel, and identify linkages to adjacent town owned and state owned open space parcels. The following tasks were undertaken as part of the improvement plan:

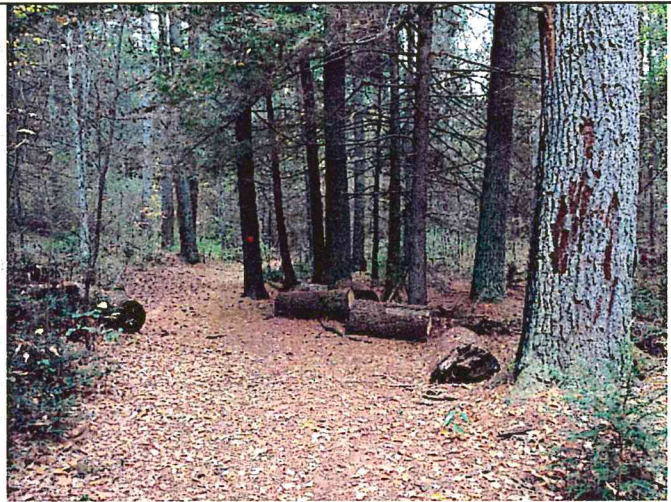
Orange Trail

Existing Conditions: primarily an eight foot wide trail that is in good condition. Trail does have sections of narrower, varied segments as described below.

Primary access into subject parcel, Bridge crossing of Stratton Brook, Narrower, undulating and serpentine section with exposed roots, Views of Stratton Brook, Intersection with Green Trail

Wider trail, Highest trail elevation on site, Traverses up and over ridgeline with steep section connecting to Orange Segment – C

Wider trail, Traverses toe of slope near east property line, Steep Section connects to Blue Trail north

As the primary site access the trail should be considered for modifications to comply with trail accessibility guidelines.

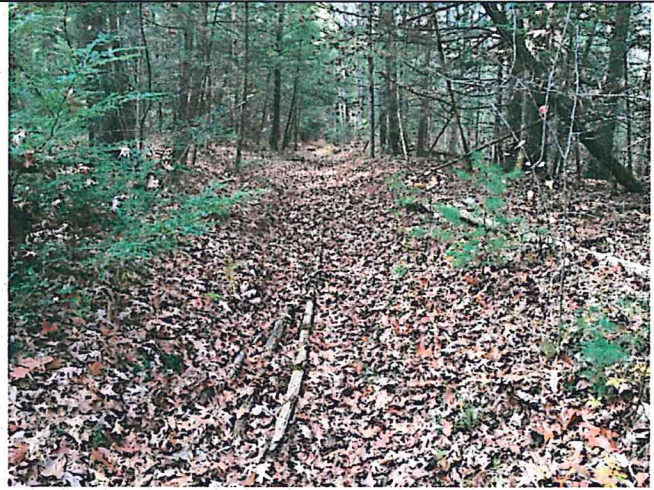
Green Trail

Existing Conditions: eight foot wide trail that is in good condition. Fairly flat for majority of length.

Trail should be considered for modifications to comply with trail accessibility guidelines.

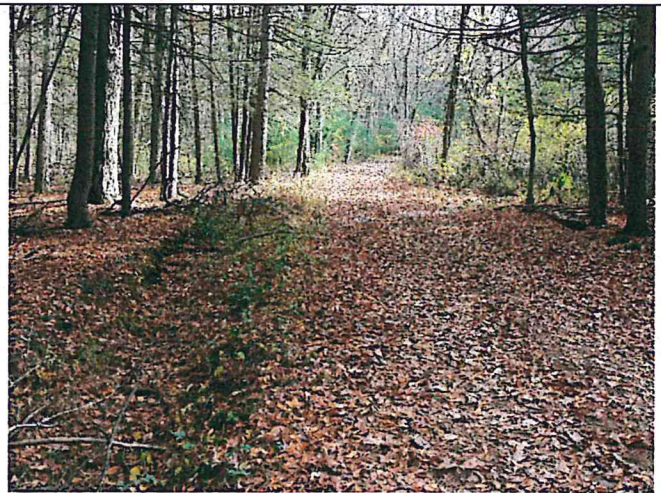
Blue Trail North

Existing Conditions: 15-foot wide gravel and compact sand road. Primary Access Trail/Road into property and to existing Ethel Walker School Wellfield. Trail in good stable condition with some vehicle ruts in low lying areas.

Trail should be considered for modifications to comply with trail accessibility guidelines.

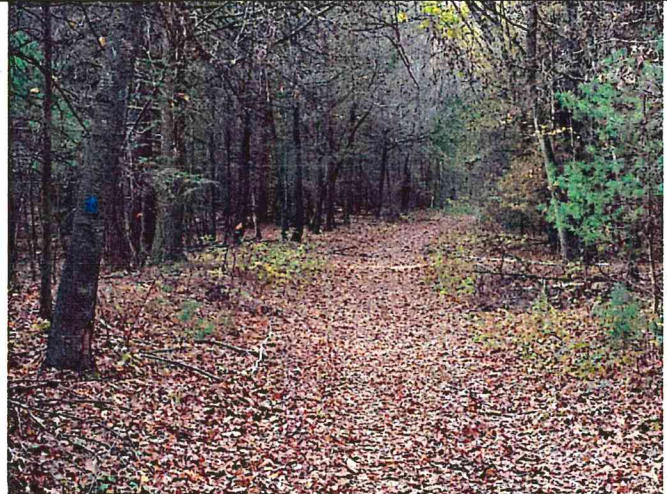
Blue Trail South

Existing Conditions: 15-foot wide gravel and compact sand road. Primary Access Trail/Road into property and to existing Ethel Walker School Wellfield. Trail in good stable condition.

Trail should be considered for modifications to comply with trail accessibility guidelines.

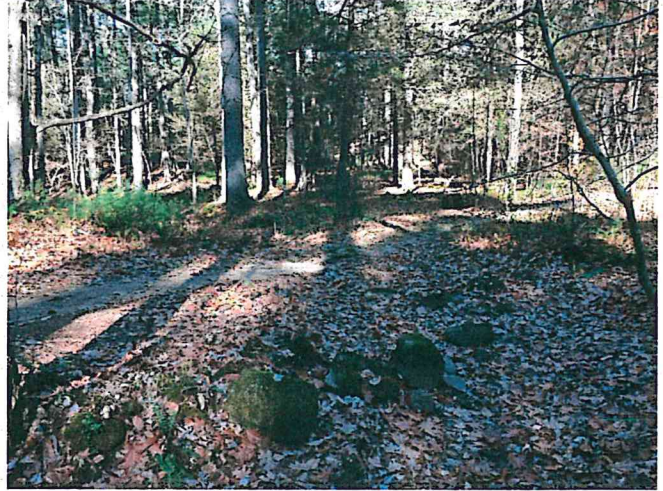
Yellow Trail

Trail Difficulty: Moderate, Trail is generally rolling terrain with a few very steep sections of grades above 10%. Care should be taken on steep sections due to loose soil and rocks.

Existing Conditions: Eight foot wide trail that is in good condition. A number of unmarked trail spurs intersect the trail at various points

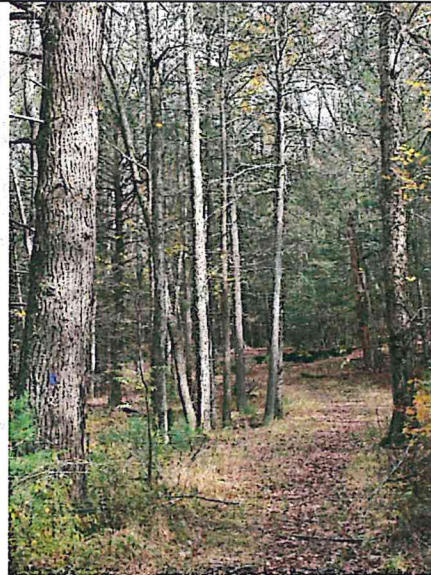
Purple Trail

Trail Difficulty: Low, Trail is generally flat with its southern section having grades between 5-7%. Ruts in southern portion of trail makes secure footing difficult

Existing Conditions: Eight foot wide trail that is in fair condition. Southern section is uneven, rutted terrain apparently from vehicle use. Intermittent drainage crossing needs improvements

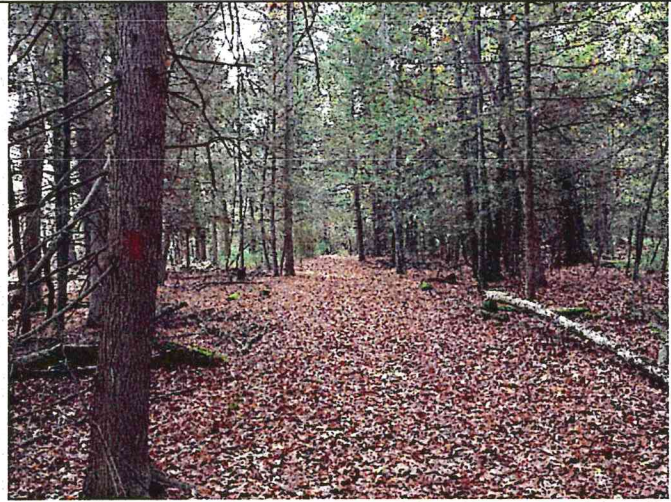
Red Trail

Existing Conditions: eight foot wide trail that is in good condition. Trail narrows in places with dense undergrowth (white pine and black birch saplings) causing trail width reduction.

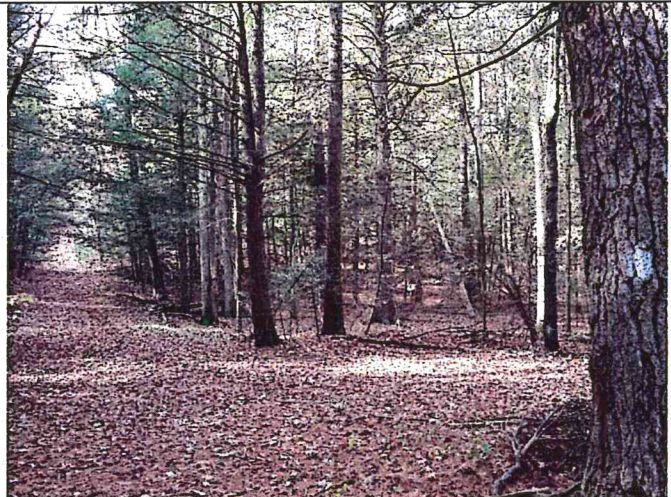
White Trail

Existing Conditions: eight foot wide trail that is in fair condition. Trail has steep sections on both east and west ends that have developed rills, gullies, and loose soil due to erosion

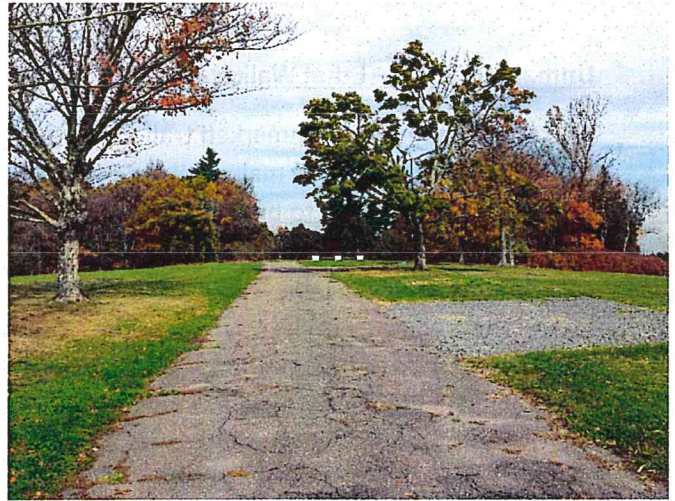
Parking at Ethel Walker School

Secondary parking is available on the Ethel Walker School property adjacent to the schools observatory. This is a small gravel area for approximately three vehicles.

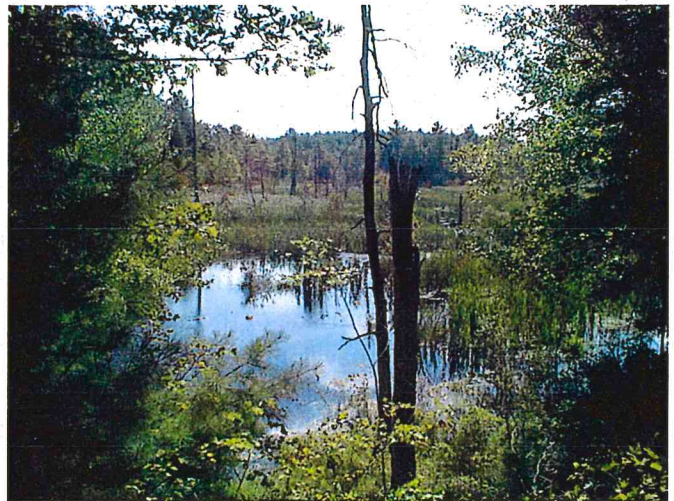
Stratton Brook Emergent Wetland System

The largest and most significant wetland system on site is Stratton Brook and its tributaries along the western boundary of the site. Stratton Brook has two distinct flow regimes. A portion of the brook is impounded by a former beaver dam. Flow is quiescent here with moderate sized expanses of open water. The beaver dam has formed an impoundment upstream resulting in the formation of scrub-shrub and emergent marsh wetland habitats. The water is shallow and warm since there is little canopy to provide shade. Although there are no published fishery surveys for this reach of Stratton Brook, it is clearly a warm-water fishery supporting species such as sunfish, grass pickerel, white sucker, brown bullhead, perch and bass.

type. Common reed (*Phragmites australis*) has become a dominant invasive plant within both the scrub shrub, emergent marsh, and evergreen forested wetlands along Stratton Brook. Its domination is beginning to lower biodiversity within the wetlands and the colonies of this species is spreading rapidly through the Stratton Brook impoundment system.

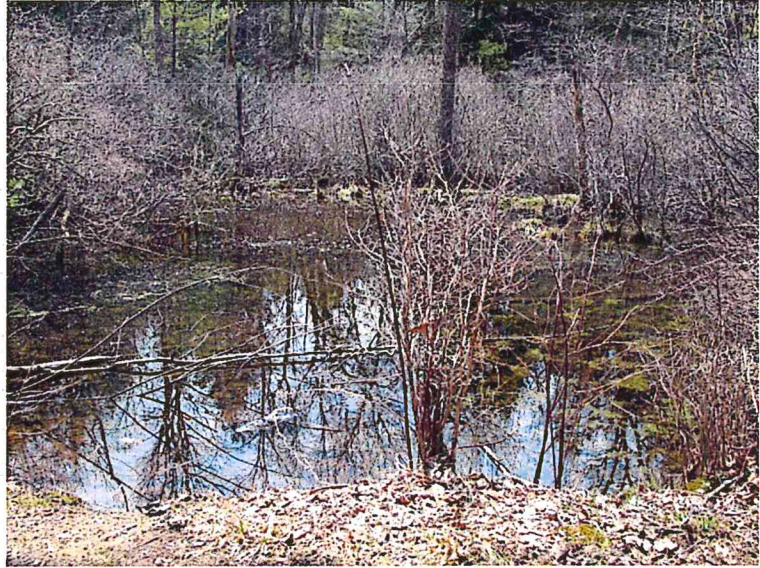
Vernal Pool-7

Vernal pool seven is located within in the northern portion of the site and is located adjacent to Blue Trail North. The pool abuts the trail which acts as a berm. This pool system has two distinct wetland communities associated with it. The northern part of the pool is a scrub-shrub/emergent marsh habitat, while the southern part is a shrubby/ hemlock forested habitat. Both of these habitats provide high quality amphibian breeding habitat. The scrub-shrub/emergent marsh pool habitat is dominated by shiny winterberry, common winterberry, silky dogwood, buttonbush, and speckled alder. The herbaceous plants included jewelweed, lesser bur-reed, fringed sedge, water smartweed, and sensitive fern. The forested pool habitat is dominated by Eastern hemlock with a moderate density of common winterberry growing within it. Typical species that have been observed within this pool include spotted salamanders, wood frogs, red-spotted newts, green frogs, spring peepers, and odonates.

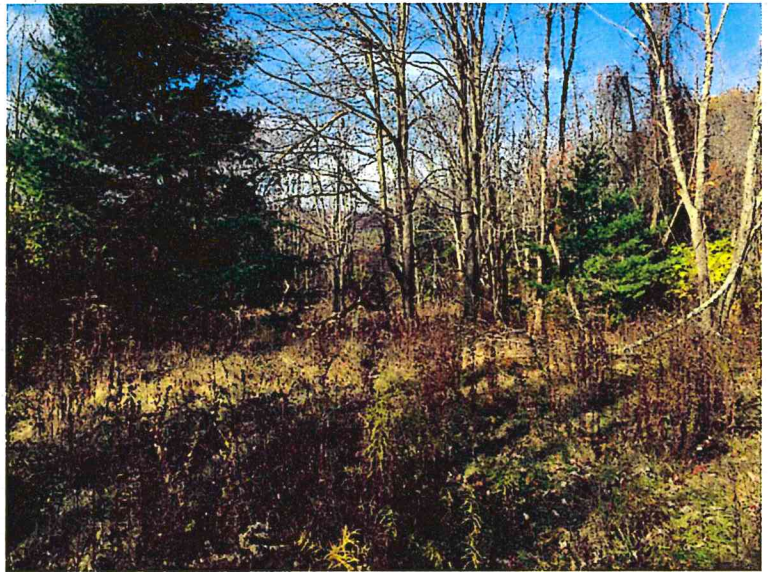
Wegner Meadow

Wegner meadow served as part of Ethel Walkers equestrian jumping area, however it is evident by the lack of recent mowing and the colonization of woody vegetation within the meadow that this site is no longer being used for such activities. The meadow appears to have not been mowed for at least five years. Many sapling and pole sized trees have grown up into islands within the meadow. Areas formerly having grass species are now being dominated by goldenrods, autumn olive, multiflora rose, oriental bittersweet, eastern red cedar, white ash, and red maple. Autumn olive, multiflora rose, and oriental

bittersweet are considered nonnative invasive vegetation. These species typically outcompete native vegetation, lower biodiversity, limit site accessibility, and can become a vector for spreading seed (bird dispersal, animal dispersal, and/or wind dispersal) into other areas of the site.

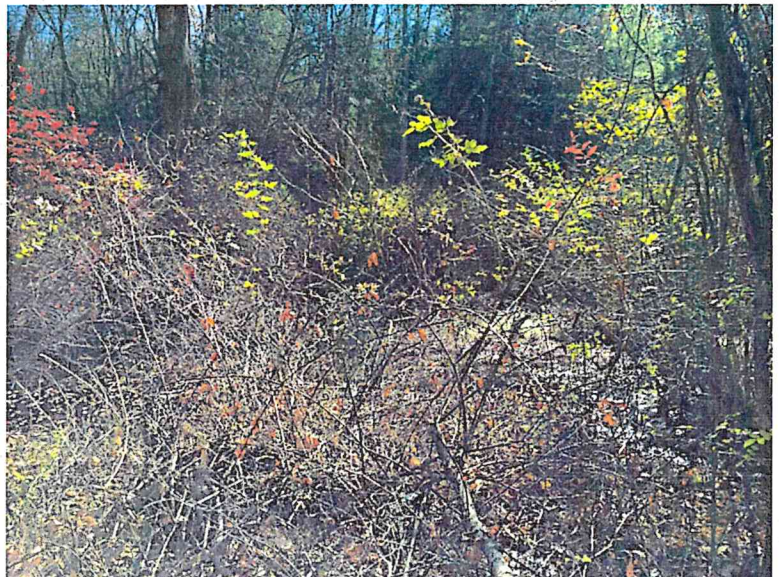
Multiflora rose and Japanese barberry within VP-7 wetland

The forested wetland located near VP-7 is becoming colonized by multiflora rose and Japanese barberry. These species are growing adjacent to the trail and can become a safety hazard to trail users. These plants are also diminishing the aesthetic quality of the wetlands and lowering biodiversity.

been connected to the harbinger of Lyme disease-infected ticks. In fact, the Connecticut Agriculture and Experiment Station (CAES) estimates that eliminating stands of Japanese barberry from forested areas can reduce the number of Lyme disease-infected ticks on a given property by 80 percent. To help prevent further migration and/or spread of these invasive shrubs other areas on site would decrease the potential for public health issues.

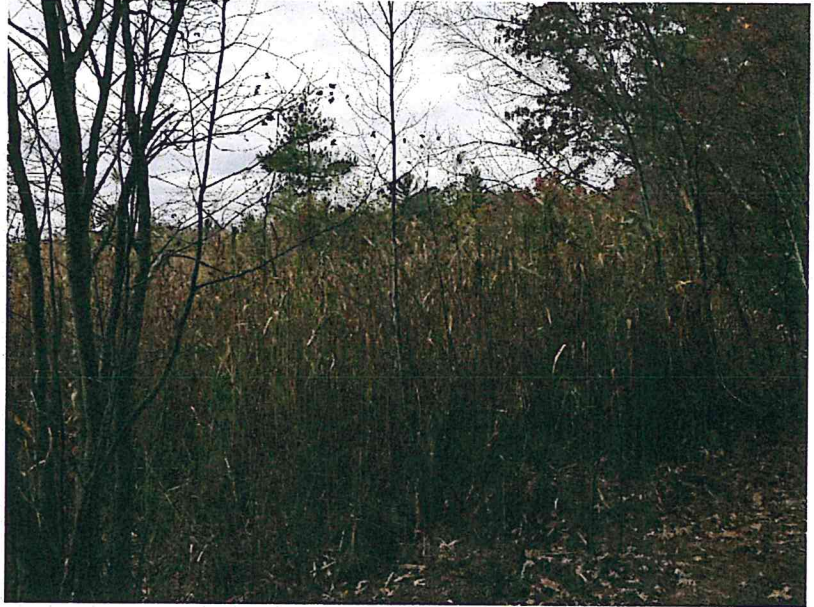
Stratton Brook Wetland System

The Stratton Brook Wetland system is being heavily infested with common reed. Common reed is an aggressive emergent wetland plant that can outcompete most herbaceous and woody vegetation. The plant forms dense monoculture community. Common reed can reach heights in excess of 12 feet, which can cause shading that can suffocate the native wetland plants. The resulting dominance of these species typically results in depressing biodiversity (fauna and flora species) within a wetland, often impedes vistas of wetlands, and lowers aesthetic value.

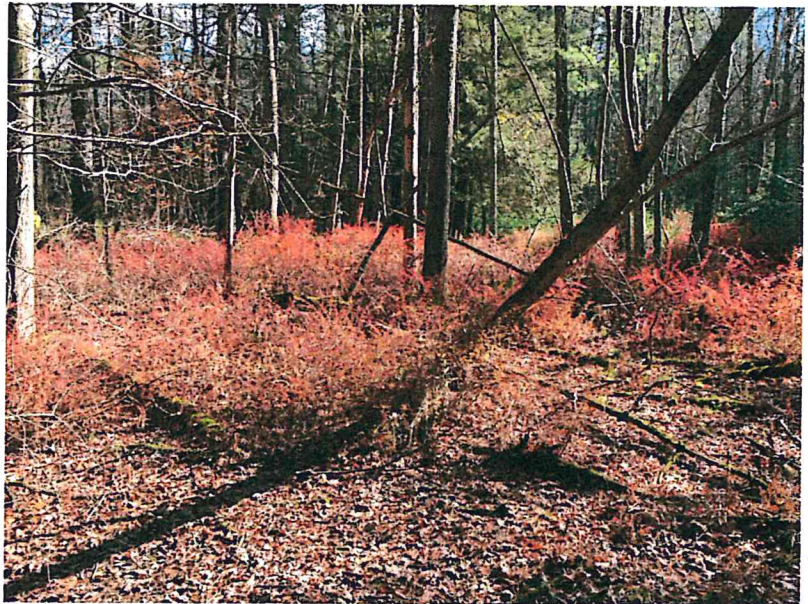
As stated previously invasive vegetation occurs in relatively low densities on this property, however there are some areas that have invasive species intermixed within the forested understory. Japanese barberry and multiflora rose are the dominant invasive species found within these forested understories. Japanese barberry is a known to provide habitat for a variety of small mammals including field mice and has
